TECHNICAL REPORT

SWERR-TR-72-35

INFRARED NONDESTRUCTIVE TESTING OF LAMINATED
STRUCTURES AND ELECTRICAL CIRCUITS

June 1972

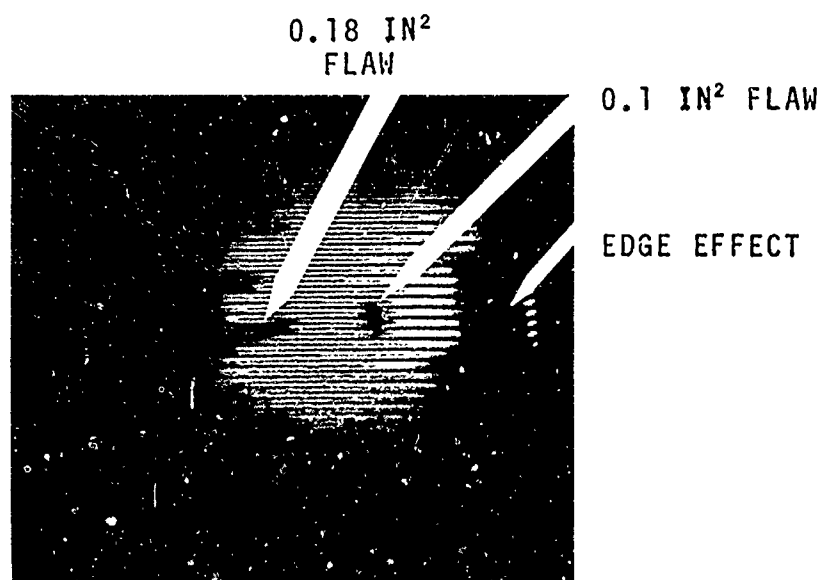
FIGURE 6

Laminated flat samples containing programmed unbonded areas were tested by the external heating technique previously described. The first tests were performed with the infrared lamp as a heat source to inspect flat aluminum/Rulon and aluminum/Plexiglas laminates. The sample used in Test 1 was a 6.0 x 6.5 x 0.1-inch aluminum sheet with a 5.5 x 1.0 x 0.006-inch strip of Rulon A (iron oxide-filled Teflon) bonded to the surface. The radiation from the lamp was incident on the rear of the aluminum sheet while the camera was focused on the other side, facing the Rulon strip. The surface temperature profile of this specimen is shown in Figure 6 with the dark (cool) spots indicating unbonding areas. On the right side of the photograph, an area exists that appears to be a gross discontinuity. This is

THERMAL IMAGE OF ALUMINUM/
RULON A LAMINATE

caused because the Rulon strip does not extend to the edge of the aluminum sheet. Since the surface of the aluminum sheet is hotter than the surface of the Rulon, a discontinuity appears along the edge.

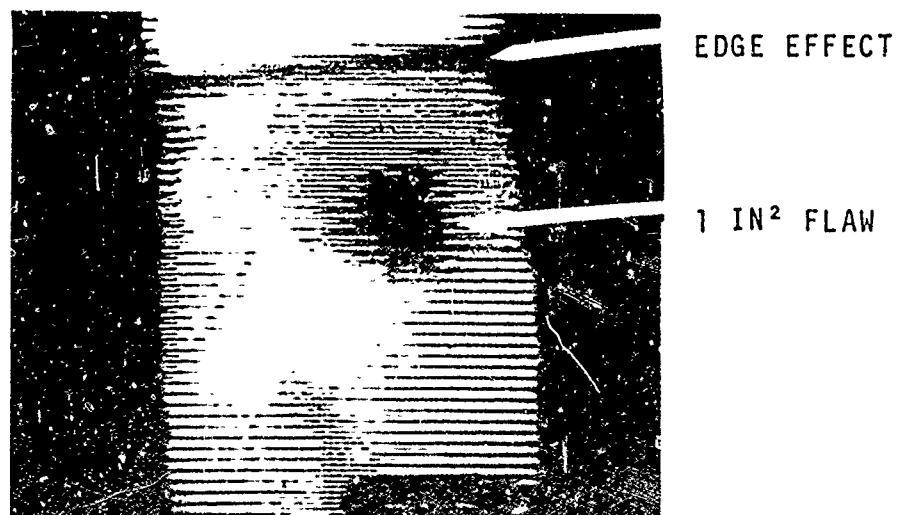
FIGURE 7

THERMAL IMAGE OF ALUMINUM/
0.25-INCH PLASTIC LAMINATE

The sample used in Test 2 was a 5.75 x 4.375 x 0.03125-inch aluminum sheet with a 5.0 x 4.0 x 0.25-inch plastic sheet bonded to the surface. The camera was focused on the plastic sheet with the heat incident on the rear of the aluminum sheet. The resulting surface temperature profile is shown in Figure 7 with the dark spot indicative of an unbonded area. An edge effect is also shown in this figure.

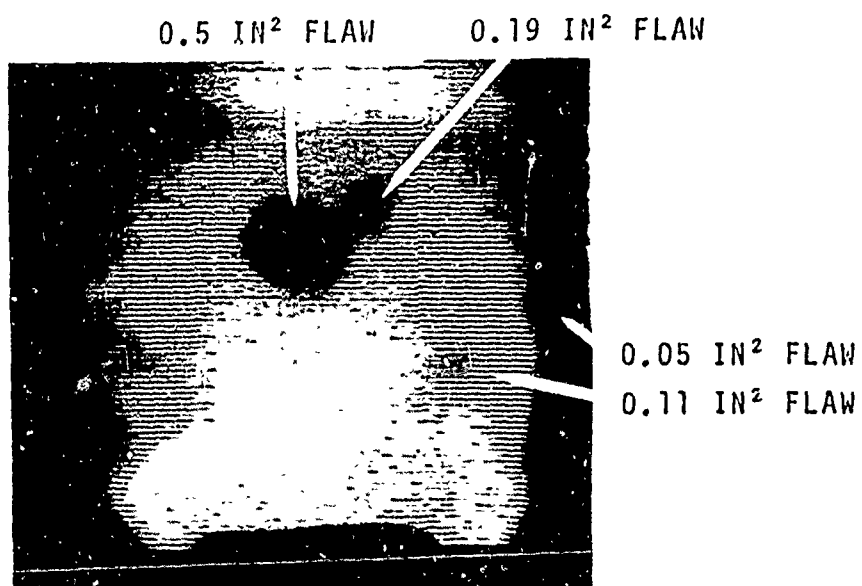
FIGURE 8

The sample used in Test 3 was a 6 x 4 x 0.095-inch aluminum sheet with a 6 x 8 x 0.25-inch Plexiglas sheet bonded (with epoxy) to the surface. The aluminum sheet was heated by the lamp, and the camera was focused on the Plexiglas surface. The surface temperature-map is shown in Figure 8 with the four dark spots indicative of the unbonded areas.

THERMAL IMAGE OF ALUMINUM/
0.25-INCH PLEXIGLAS LAMINATE

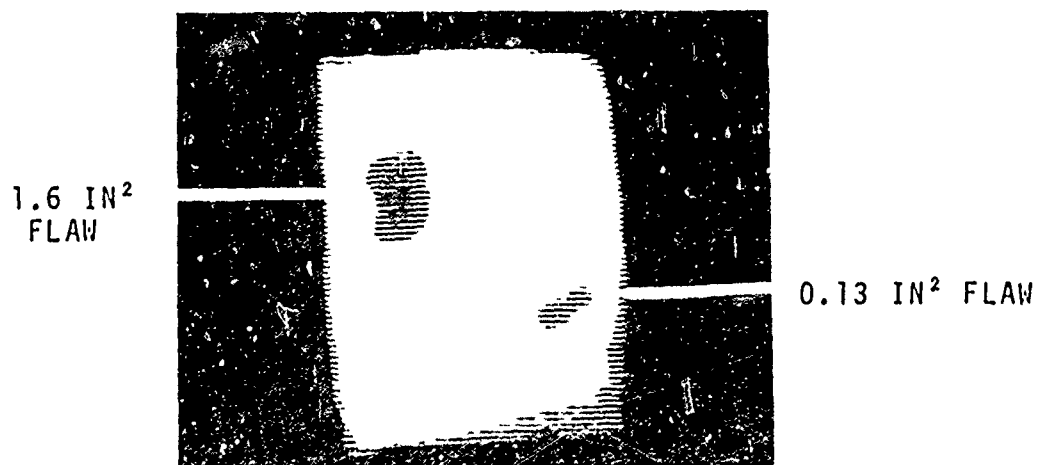
FIGURE 9

The sample used in Test 4 was a 5.75 x 4.5 x 0.04-inch aluminum sheet with a 5 x 4 x 0.025-inch plastic sheet similarly bonded to the surface. As before, the aluminum sheet was heated and the camera was focused on the plastic surface. The surface temperature-map of this specimen with the two dark spots indicative of unbonded areas is shown in Figure 9.

THERMAL IMAGE OF ALUMINUM/
0.025-INCH PLASTIC LAMINATE

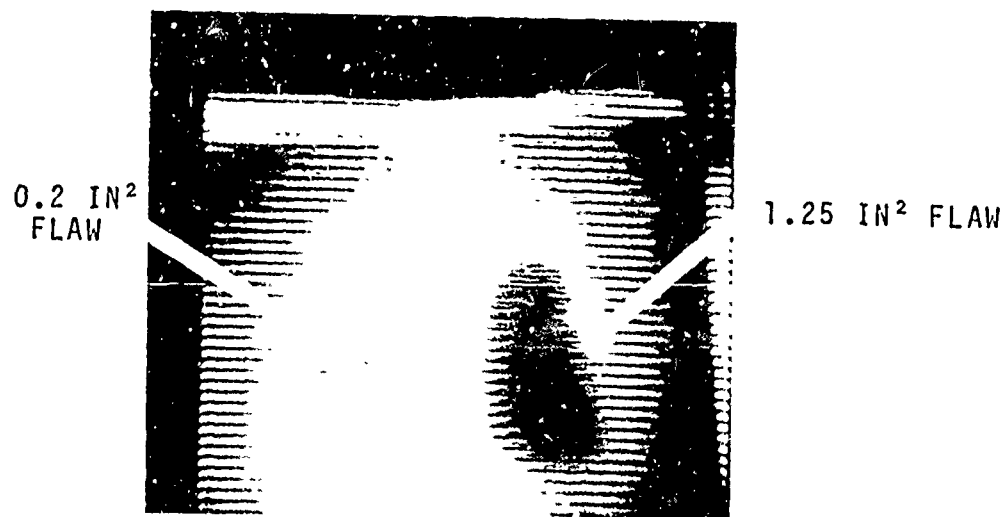
FIGURE 10

The sample used in Test 5 with the infrared lamp was a 8 x 8 x 0.2-inch aluminum sheet with a 4 x 7 x 0.1-inch Plexiglas sheet bonded to the surface. The same heating and viewing configuration used previously was used in this case, the resulting thermal image is shown in Figure 10. The entire test specimen is not shown in the figure; actual dimensions of the section shown in the image are 5 x 3 inches.

THERMAL IMAGE OF ALUMINUM/
0.1-INCH PLEXIGLAS LAMINATE

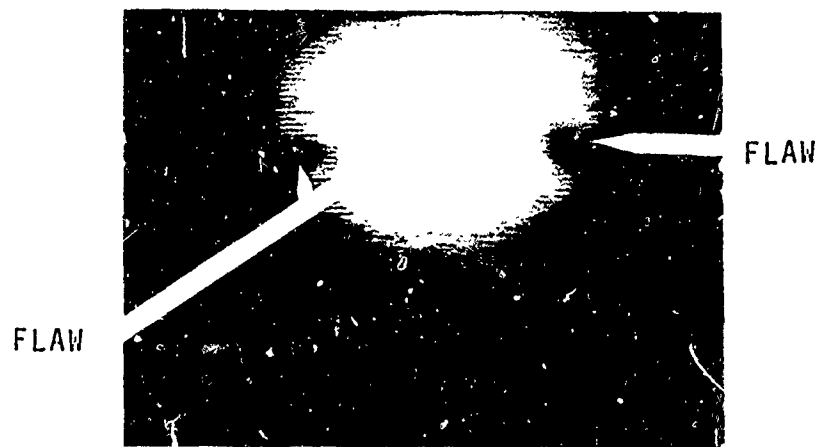
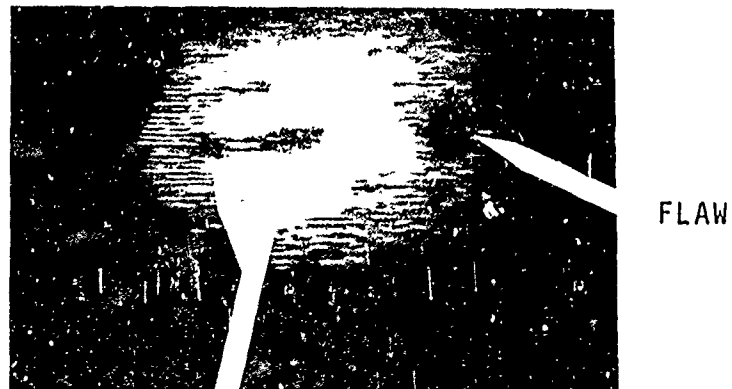
FIGURE 12

In the next test with the laser heat source, the aluminum/Rulon A composite, previously described, was inspected. As before, the laser energy was incident on the aluminum while the camera was utilized to monitor the thermal signature of this sample. The signature that resulted from the use of a stationary unfocused laser heat source is shown in Figure 12, View a, and the signature of the sample resulting from the use of a scanning laser heat source is shown in Figure 12, View b.

FLAW
VIEW b
UTILIZATION OF A SCANNING LASER SPOT

THERMAL IMAGE OF ALUMINUM/
RULON A LAMINATE

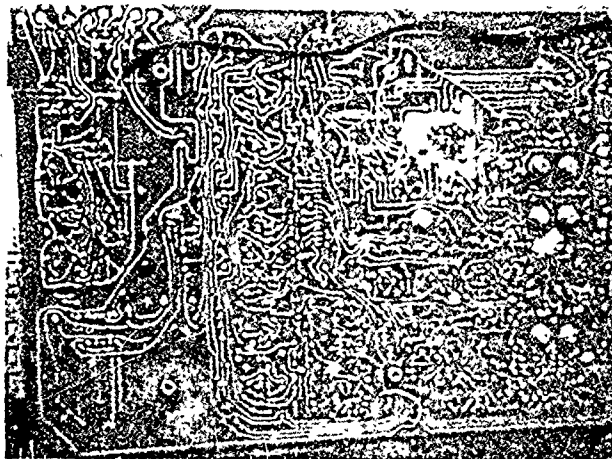
FIGURE 14

During the FY72 IRNDT investigation, the electrical circuit testing was limited to the inspection of the circuit board of a digital voltmeter. This particular instrument was not operating reliably and had a mean time before failure of approximately 8 hours, with the same two transistors failing in each case.

To determine whether any abnormal thermal concentrations were present on the circuit board, the electronics were removed from the case and the unit was allowed to operate while the infrared camera was focused on the circuit board. A conventional photograph of the underside of the circuit board is shown in Figure 14, View a. The thermal image of the circuit board is shown in Figure 14, View b. The hot spot (white) in the upper left of this view was caused by a resistor by which the board was heated. The transistors that were of interest are located below the hot resistor in the locations indicated. An isometric image of the circuit board is shown in Figure 14, View c. In this type of image, amplitude modulation of the horizontal line

RESISTOR

TRANSISTORS

BACK SIDE OF CIRCUIT BOARD

scan is used to present a 3-dimensional temperature-map. The peaks in this view indicate hot spots.

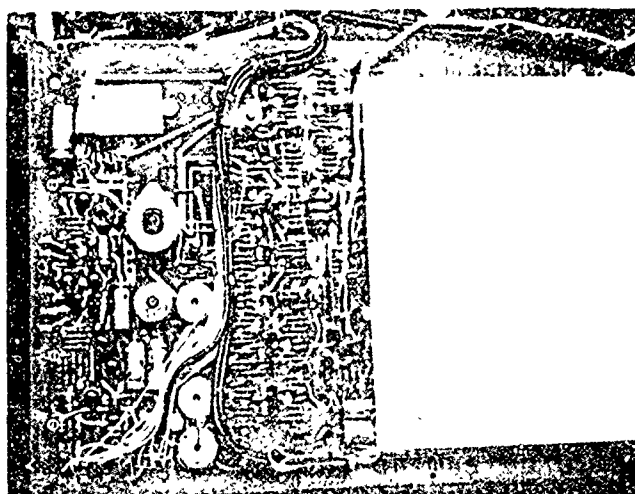
FIGURE 15 VIEW OF CIRCUIT BOARD

Since the thermal image of the bottom of the printed circuit board did not yield all the necessary information, the board was rotated 180° (top to bottom) and the temperature profiles of this surface were monitored. A photograph of the area under inspection is shown in Figure 15, View a, (Note: What was shown at the top in Figure 20 is now at the bottom). The thermal and the isometric images of this side of the board are shown respectively in Figure 15, Views b and c with the location of the components of interest marked. Since the transistors that had been failing after prolonged use (8 hours) were operating at a higher temperature than the comparable units in the circuit, these transistors were replaced by transistors with comparable electrical characteristics but with a higher power dissipation capability. In addition, the gold cases of these transistors, which have a very low emissivity (typically less than 0.1), were painted with ultra flat black-enamel, which has an emissivity of greater than 0.95, to improve the radiative heat transfer characteristics. After these transistors had been changed, the instrument was operated continuously for three 8-hour periods without malfunctions; the unit has also operated reliably during normal use after the test period. Therefore, the ability to use infrared nondestructive testing techniques for electrical circuit analysis was also shown during this investigation.

PLSISTOR TRANSISTORS
